Trouble report & countermeasure on MGO mandatory use

**MES Technoservice Co., Ltd.
Diesel Engine Service Division
Technical Dept.**

Aug. 2015

Trouble report on MGO mandatory use

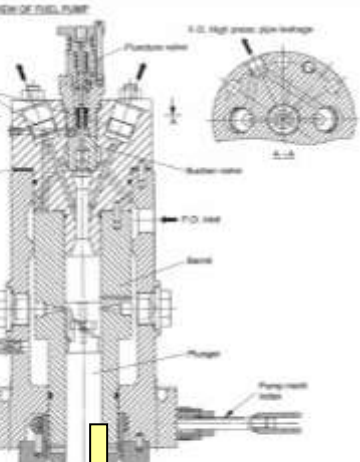
Trouble report on MGO mandatory use : Case 1

Trouble Case-1	Crew's Action
<ol style="list-style-type: none"> 1. Difficulty of astern starting 2. Difficulty of engine rev. increase 	<p>Increased fuel pump index by change-over to emergency control.</p>
<h2>Cause</h2>	<h2>Countermeasure</h2>
<p>Big leak occurred in MGO having low viscosity even if no leak in HFO operation.</p>	<ol style="list-style-type: none"> 1. Measurement of the clearance at forthcoming dry dock or calling port

<p>Allowable clearance: excess 50% than original</p> <ol style="list-style-type: none"> 2. Renewal of FO pump cylinder

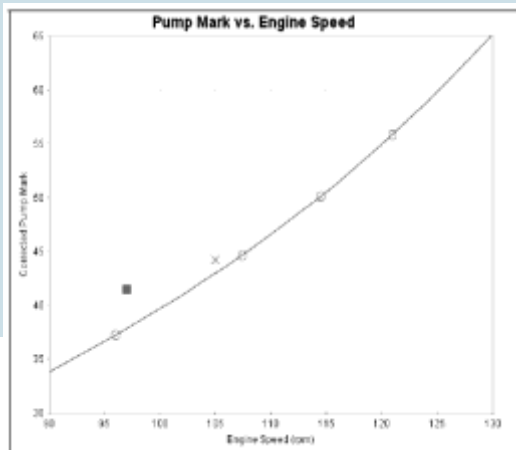
Internal leakage in fuel pump

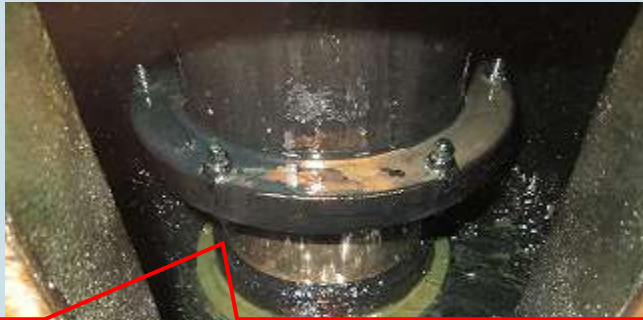
Trouble report on MGO mandatory use : Case 2

1. Fluctuation of fuel oil pressure
2. Much amount of fuel oil drain from lower pump cylinder

Engine inlet FO viscosity was less than 2 cSt. due to high temp.

Much fuel oil leak down to drain line.
About 10L/h fuel drain can be seen at shop test.

1. Renewed inlet valve for FO steam tracing pipe.
2. Closed valve completely for FO heater and changed into by-pass line for FO heater.

Fuel oil line and steam tracing line are to be checked surely before using MGO.

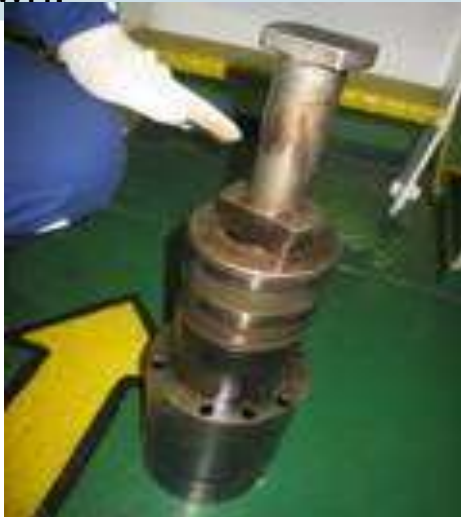
Trouble report on MGO mandatory use : Case 3

Trouble Case-3	Crew's Action
1. Fluctuation of FO pressure 2. Knocking noise & lowering of engine revolution	Air ventilation and renewal of FO pump cylinder were done.
Cause	Countermeasure
Vapor lock in FO line and slight sticking of FO pump cylinder were considered, but clear reason was unknown.	1. Careful handling for MGO 2. Using of lubricity improver 3. Regular maintenance of FO pump

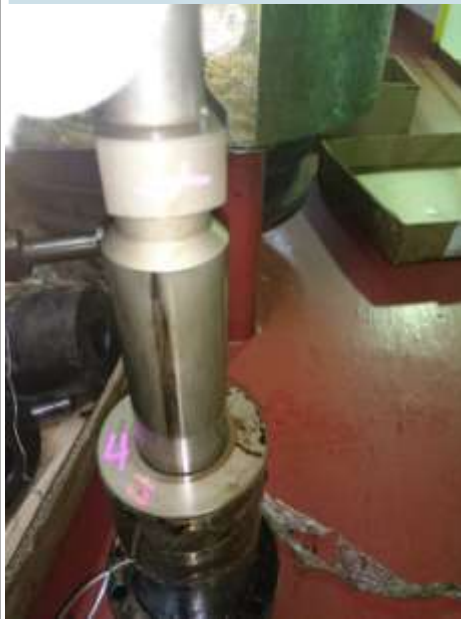
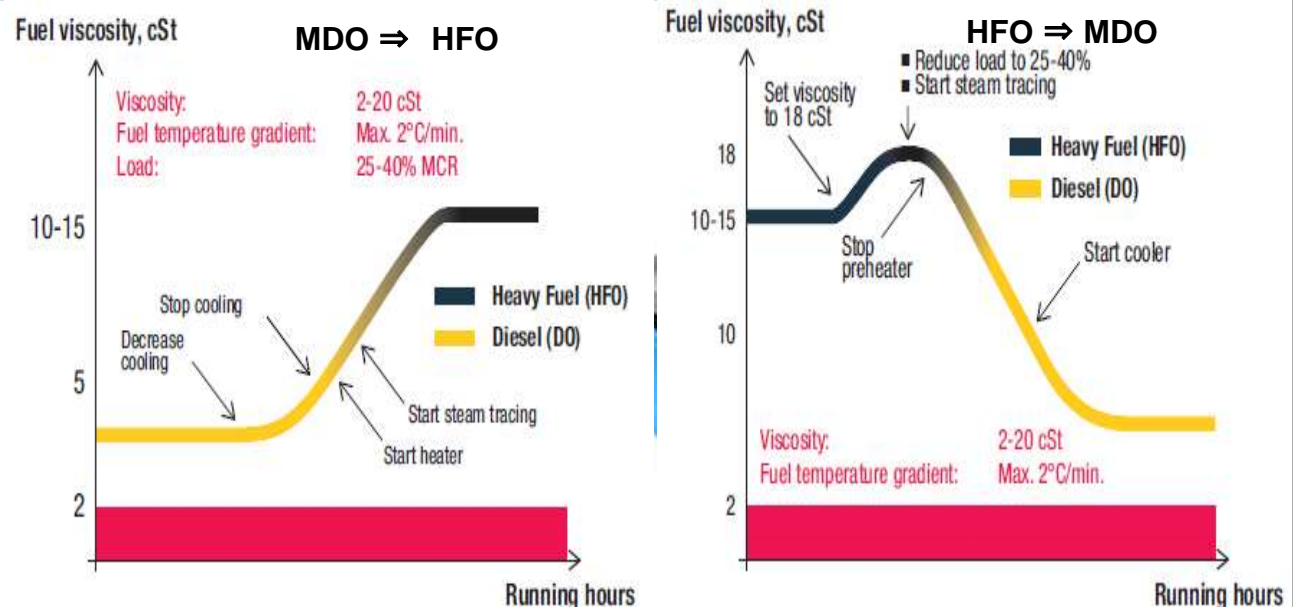
Trouble report on MGO mandatory use : Case 4

Trouble Case-4	Crew's Action
Sticking of FO pumps during change-over MGO to HFO	Repair and Renewal of FO pumps
Cause	Countermeasure
Thermal shock due to rapid temperature change of fuel oil	Correct fuel oil change –over with careful temperature gradient: Max. 2 °C/min
