# TECHNO NEWS

<b>Recommendation for periodical maintenance of Governor and Remote control system (supplementation)</b>		<b>No.071</b>	
		<b>APPROVED</b>	<b>Y. Nishioka</b>
		<b>CHECKED</b>	
		<b>PREPARED</b>	<b>H. Miyake</b>
<b>ENGINE TYPE</b>	<b>BMS2000II, MAG200II</b>	<b>DATE</b>	<b>2010/12/3</b>

**BMS-NEWS NO.010-03**

**Recommendation for the periodic maintenance for the  
BMS and the Governor (supplementation)**

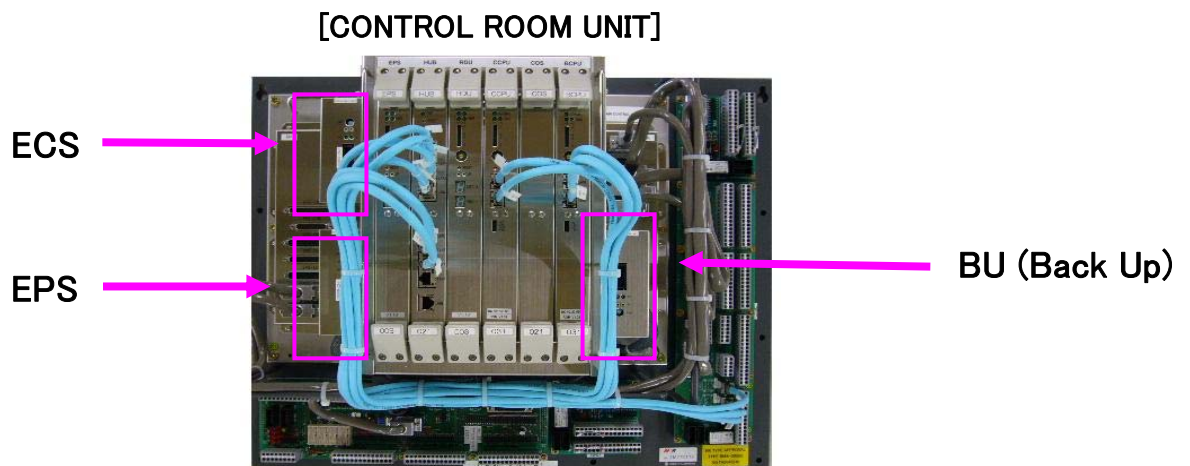
#### 1) PWR(POWER) UNIT AVR (Automatic Voltage Regulator)

The Power units AVRs for the ECS, BU and EPS systems are installed at the Control Room Unit to supply DC5V power to controlling PCBs in each system.

Each AVR is equipped with an electrolytic capacitor. The capacitor's deterioration could cause unstable power supply to the system and it may result in a system malfunction. The life-cycle of the electrolytic capacitor is approximately 10 years and replacement every 7 or 8 years is recommended.

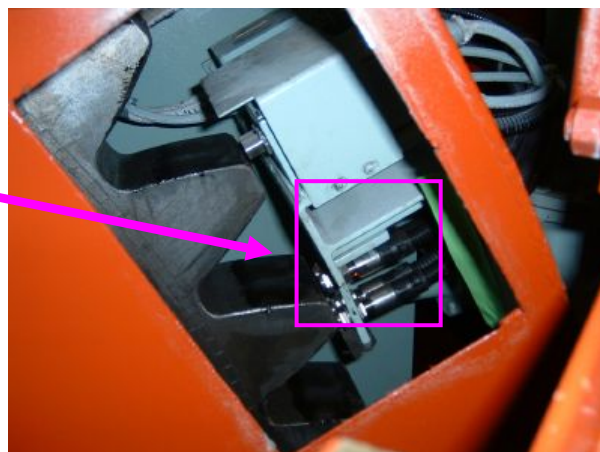
#### PICK UP SENSOR

A total of four pick-up sensors for detecting the M/E revolution are installed, which are counted as two pairs of pick-up sensors. One pair is used for the control of the BMS and the Governor and the other pair is for the EPS, Engine protecting system. Previously we have issued BMS-NEWs No.005-01 informing that the Age deterioration due to vibration or other factors such as wear may cause the barge-in of the tar constituent which the Flywheel will be tarred with, and it will affect the internal transistor circuit which could lead to the pick-up sensor abnormality, and burrs on the Flywheel teeth could cause damage to the pick-up sensors.

May we remind you to clean the sensor head which grease from the Flywheel could adhere to, and we recommend that you have the sensors replaced every five years.

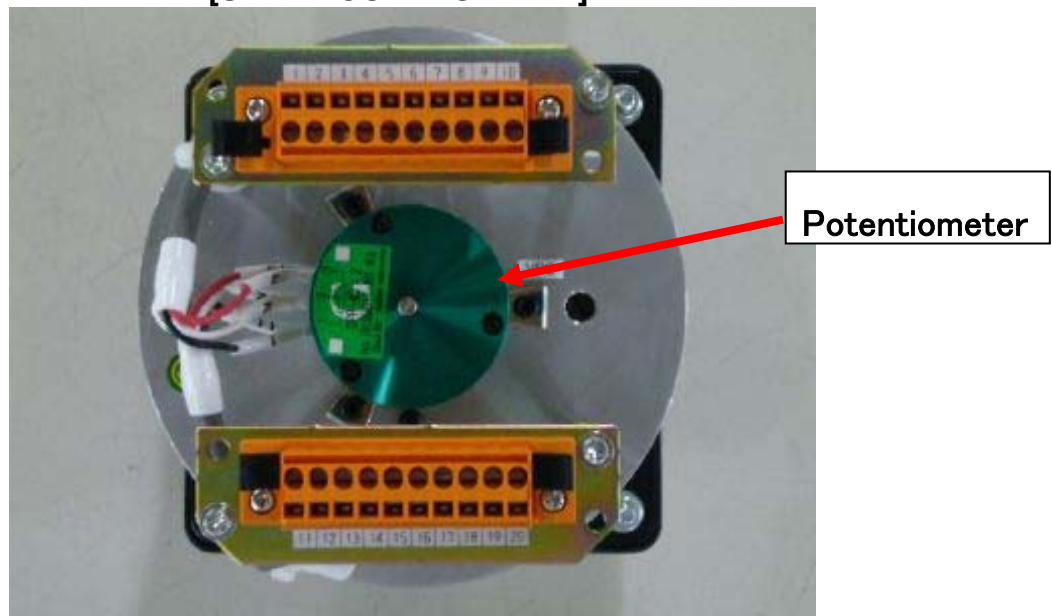
[SPEED CONTROL DIAL]

The Potentiometer installed in the Speed control dial sends the electrical signal between 0 and 10V which the M/E command rpm is converted to, and adjusts the M/E rpm.

A malfunction of the Potentiometer could result in the fluctuation of the M/E rpm under the C/R control, a failure of rpm adjustment, the M/E start failure or other serious trouble.

Replacement every 10 years is recommended.

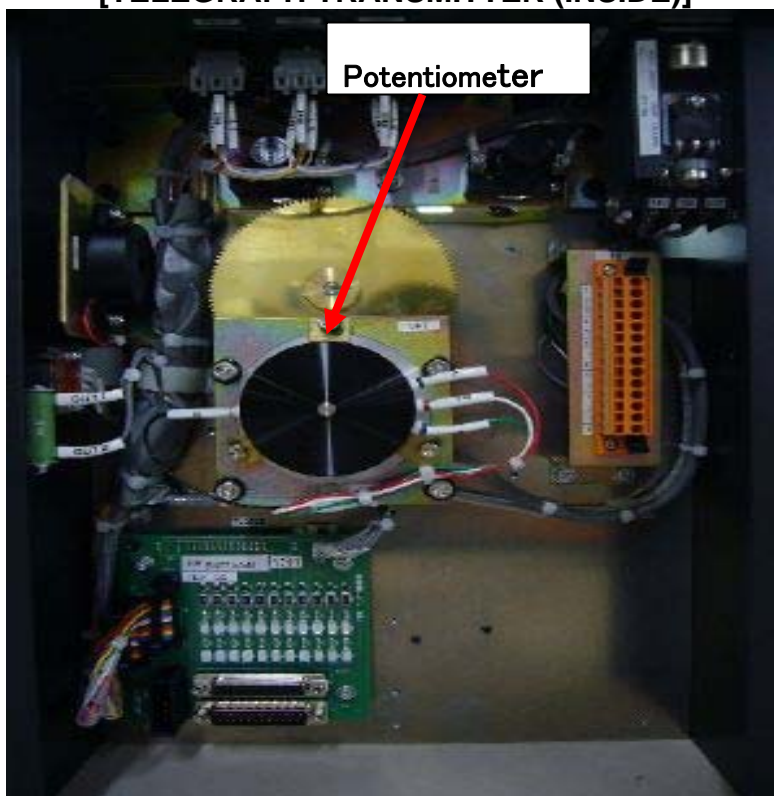
[TELEGRAPH TRANSMITTER (INSIDE)]

The Potentiometer installed with the Main Telegraph Transmitter sends the electrical signal between plus 10V and minus 10V which the M/E command rpm is converted to, and adjusts the M/E rpm.

Please note that this Potentiometer is equipped only for Main Telegraph Handle type and there are two types depending on the Handle type.

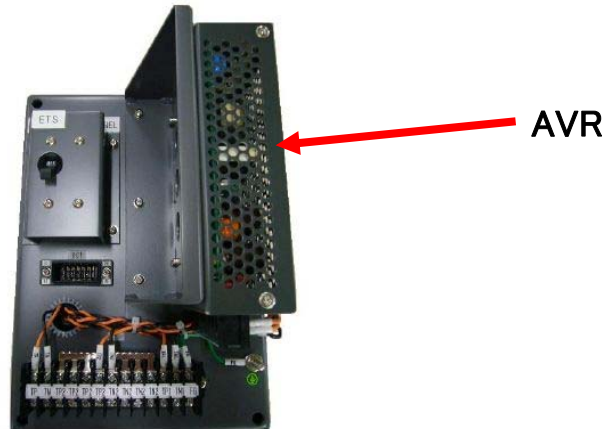
### [BRIDGE POWER SWITCH PANEL]

The AVR (Auto Voltage Regulator) is installed inside the Bridge Power Switch Panel and supplies the power to the controlling PCB of the Telegraph System. The AVR is equipped with an electrolytic capacitor whose deterioration could cause unstable power supply and malfunction of the Telegraph system.

The life-cycle of the electrolytic capacitor is approximately 10 year and periodical maintenance every 7 or 8 years is recommended.

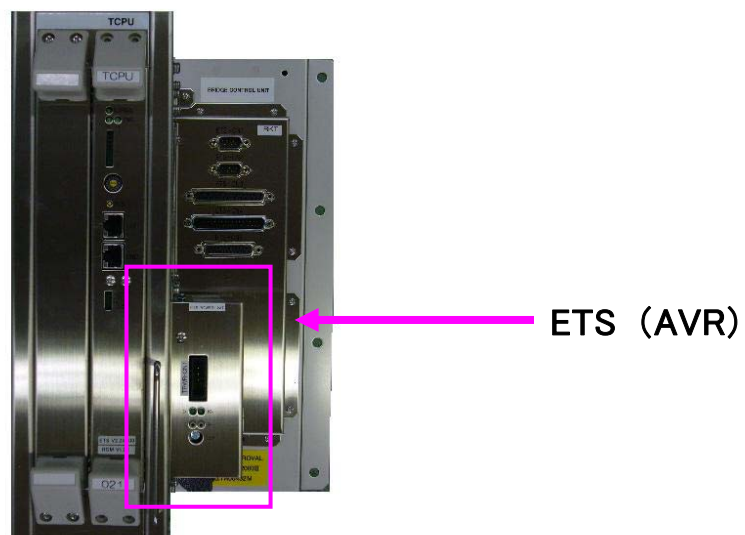
### [BRIDGE CONTROL UNIT]

The AVR (Auto Voltage Regulator) is installed inside the Bridge Control Unit and supplies the power to the PCB which controls the Bridge Maneuvering System. The AVR is equipped with an electrolytic capacitor whose deterioration could cause unstable power supply and a failure of maneuvering.

The life-cycle of the electrolytic capacitor is approximately 10 year and periodical maintenance every 7 or 8 years is recommended.

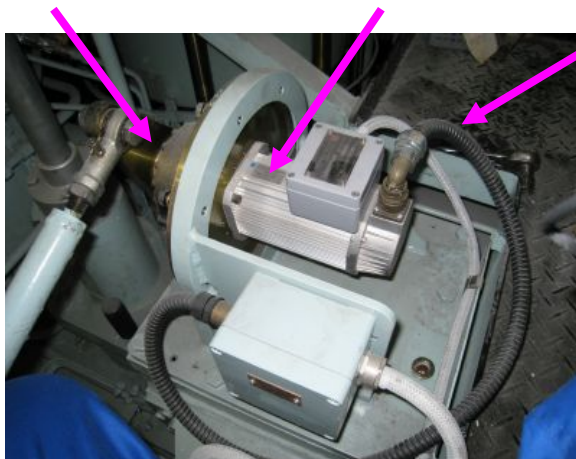
After a long period of use, the internal parts of the Motor bearing wear and deteriorate, and the grease degrades which could cause damage to the motor shaft and the bearing. It may result in the malfunction of the Governor Motor and replacement every 7 or 8 years is recommended.

After a long period of use, the Cyclo-gear wear and deteriorate, and the grease degrades which could cause damage to the Cyclo-gear. Worn gears may cause a backlash which could interfere with the correct control of the Governor. Replacement every 7 or 8 years is recommended simultaneously with the Governor Motor.

The Resolver Cable is connected with the ABS sensor installed in the Governor Motor, and is an important connector cable which informs the Servo Amp. of the Governor position. The governor won't be able to be controlled remotely if disconnection or loose connection of this cable occurs. Replacement every 7 or 8 years is recommended together with the Motor and the Reduction Gear.

\*The photo is showing the Actuator MOTOR and REDUCTION GEAR for the M/E 50MCC

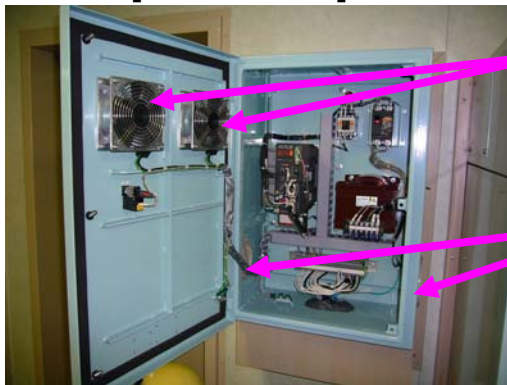
[SERVO UNIT]

There are 2 cooling fans installed on the front cover for the servo unit, which keep the unit inside cool. If these cooling fans stop operating, the temperature inside the unit will increase which may cause the malfunction of the servo driver. Replacement every 5 years is recommended.

The Air Filter is attached to the air hatch in the side of the Servo Unit. Cleaning and visual check every 6 months along with a yearly replacement is recommended.

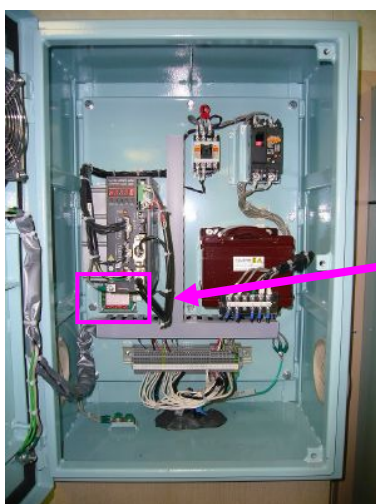
[SERVO UNIT]

The Servo driver for Large Main Engine with the Cylinder dia. 80, 90 or 98 is equipped with cooling fans. A halt of these fans could cause the rise of temperature and in the worst case the Servo Amp could be damaged. Replacement every 5 years is recommended.

The Servo Driver is equipped with a non-charging type of lithium battery to memorize the Home position of the Governor Actuator Unit. As the lithium battery weakens over time, a loss of the power supply AC220V could cause the loss of the Home position of the Actuator which could, in turn, cause the malfunction of the Governor. Replacement every 5 years is recommended.

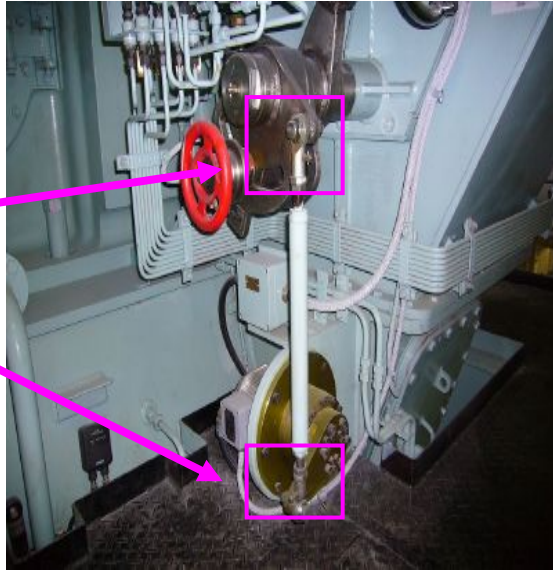
[ACTUATOR – Change-Over Clutch]

After long-term usage, excessive wear of the Ball Joints could cause failure of correctly informing the Governor output which could result in Governor hunting or failure in increase and decrease of the M/E rpm. Please refer to the below recommendation for replacement.

- Ball Joint “M” (between the Governor and the Fuel regulating gear) Every 5 years
- Ball Joint “S” (between the Fuel regulating gear and the Fuel pump) Every 10 years

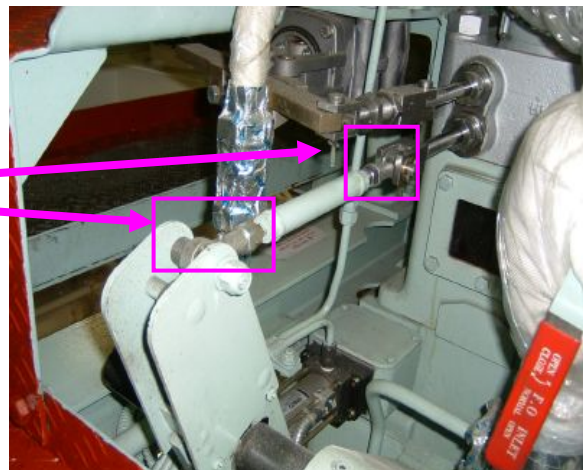
[PUMP MARK]

The Ball Joints are installed at the junction rods between the Governor Actuator and the Fuel regulating gear and at the top of the rods between the Fuel regulating gear and Fuel pumps.

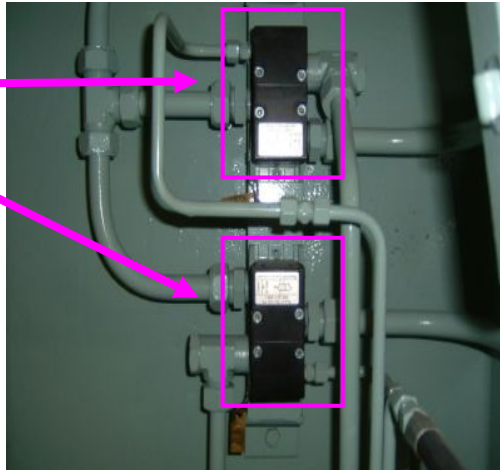
MECMAN VALVE

The Mecman Valves are pilot valves for activating the M/E starting air controlling pneumatic system. Replacement every 5 years of the complete unit is recommended.
