SERVICE NOTE

MITSUI ENGINEERING & SHIPBUILDING CO., LTD.
DIESEL TECHNICAL INVESTIGATION GROUP.

for MITSUI—MAN B&W engines, Low Load Operation (Special attention and modification based on recent service experience)		No. 179	
		APPROVED	N. Osako
		CHECKED	
		PREPARED	M. Kotake
ENGINE TYPE	All engines	DATE	27thAug. 2012

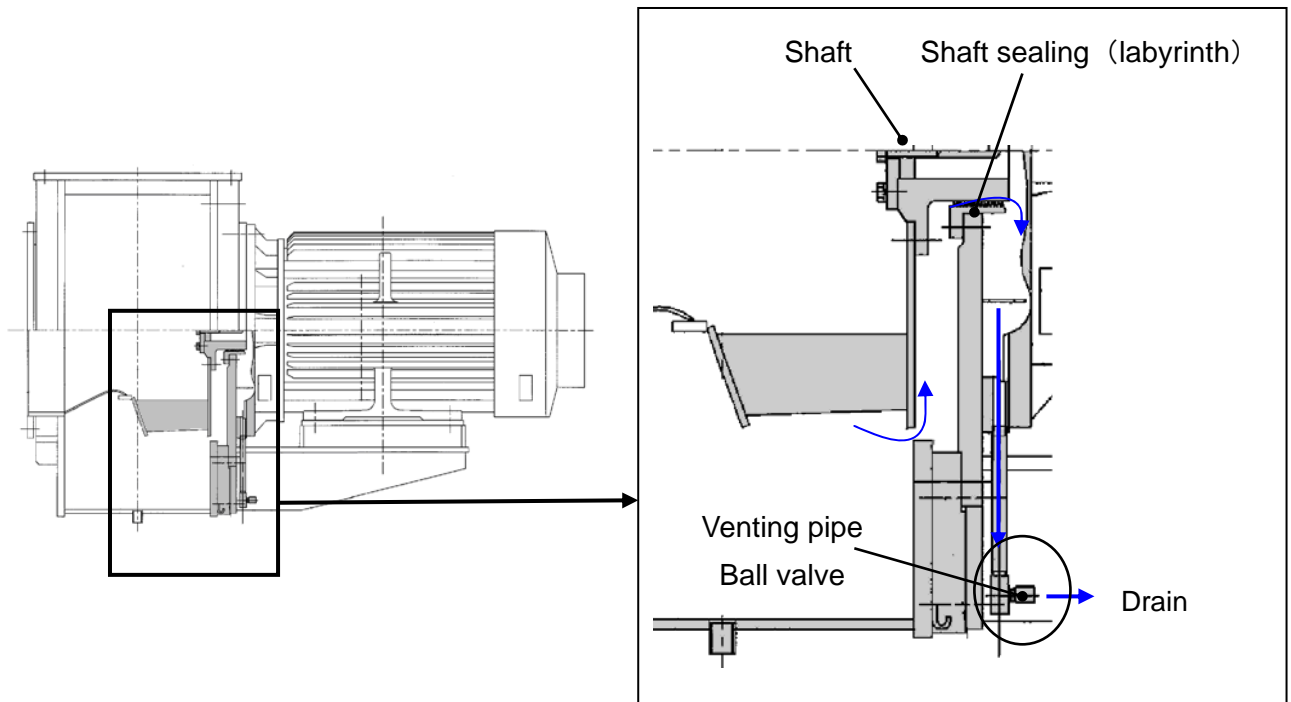
Fig. 1: Aux. blower

In connection with continuous low-load operation and, thereby, increased operation time of auxiliary blowers (A/B), an increasing number of troubles of the A/B has been reported. An increased running hours will require increased maintenance, but still a number of troubles have been reported.

If the venting pipe is closed or plugged, the scavenge air pressure will push air, sludge and impurities from the scavenge air through the bearing and, thereby, remove the lubricant from the bearing.

It is recommended to open the valve equipped at the top of venting hole at least once a week regularly for drain from the venting pipe. This valve can open and close during engine operation. Change the shaft sealing if an excessive air amount is experienced from the drain.

This is also described in the service note No.169, it is a general recommendation to carry a complete spare blower on board the vessel if low-load operation is employed for longer periods

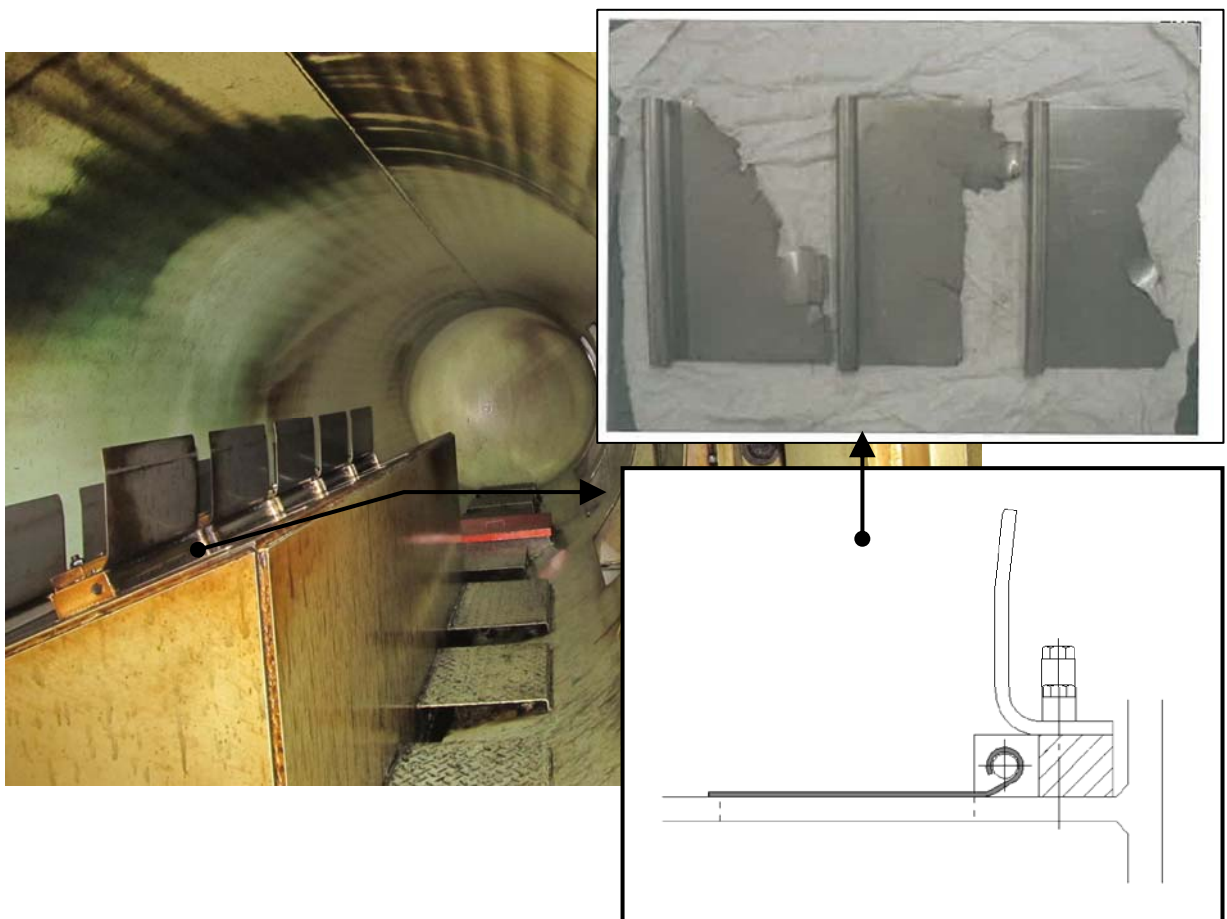
Fig. 2: Broken flap valves

There have been several reports of broken flap valves in connection with low-load operation

At some point in the load area around the switch point of the A/B, the flap valves (non-return valves) in the scavenge air receiver will be continuously opening and closing due to the pressure pulsations in the scavenge air receiver. This load area can be recognized by a distinct hammering noise from the flap valves.

The hammering of the valves will damage and/or break the valves after a short period. Operating the engine continuously in this load area must be avoided.

Broken and damaged valves must be changed at first opportunity, and valve pieces should be removed from the scavenge air space to prevent them from causing damage downstream. Broken and missing valves will have a negative impact on the engine performance when the auxiliary blowers are running.

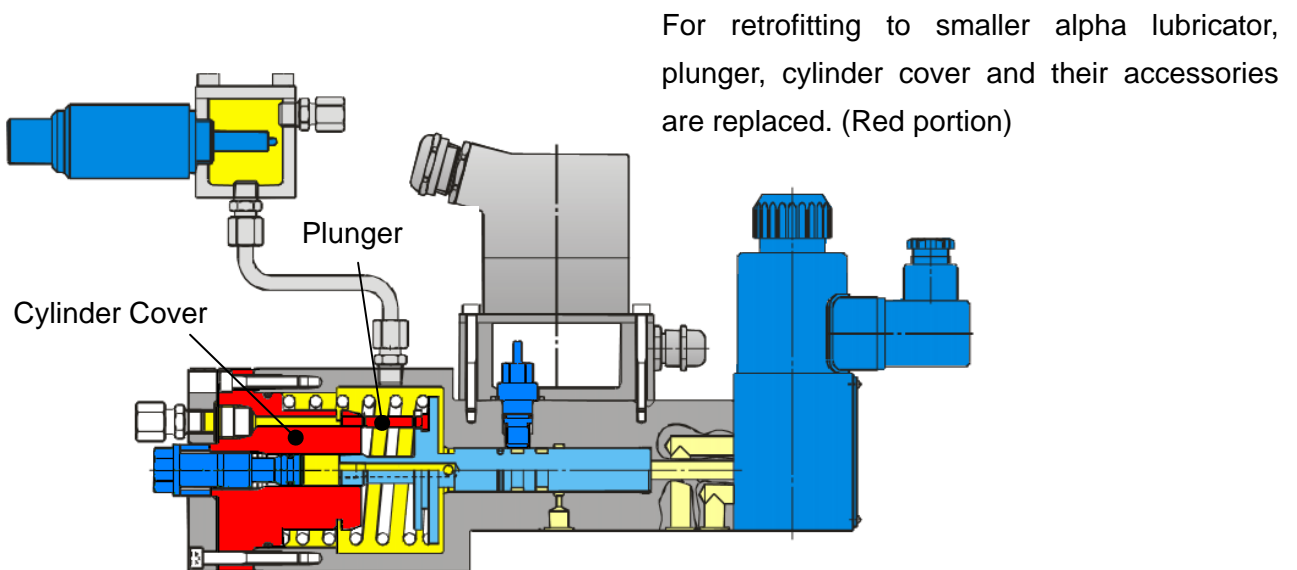
Fig. 3: Alpha Lubricator

Lower-load operation will result in an increase in the specific cylinder oil dosage (g/kWh).

The intention is to switch from Mep-proportional control or Load-proportional control to Speed-proportional control below 25% engine load. However, since the Alpha lubricator system has a limitation of maximum 15 rev. per injection in order to avoid too long intervals between lube injections on MC/MC-C engines, MEP-proportional control or Load-proportional control will be switched to Speed-proportional control at 35-40 % load, depends on cylinder oil feed rate. This may result in excessive lubrication at very low loads, which could lead to deposit build-up on the piston top lands.

We have not received any reports of damage in relation with over lubrication at low loads. However, Deposit build-up of unused lube oil and additives may be harmful to the cylinder condition, especially in connection with subsequent loading up to higher engine loads.

As illustrated in Fig. 3 and Fig. 4, smaller alpha lubricator pumps can be retrofitted, so that the Mep proportional (or the load proportional) breakpoint can be moved down to a lower engine load and Mep proportional (or the load proportional) control can be kept in more low engine load. Depending on the load pattern of the engine, this modification could show profitable for reducing operation cost, and it would reduce the fouling of the scavenge air space with excessive lube oil.

If mechanical lubricators are installed, it is highly recommended to retrofit the Alpha Lubricator. Especially during low-load operation, the mechanical lubricator will have a very high feed rate compared to the specified need.
