Trouble report & countermeasure on MGO mandatory use

**MES Technoservice Co., Ltd.
Diesel Engine Service Division
Technical Dept.**

Aug. 2015

Trouble report on MGO mandatory use

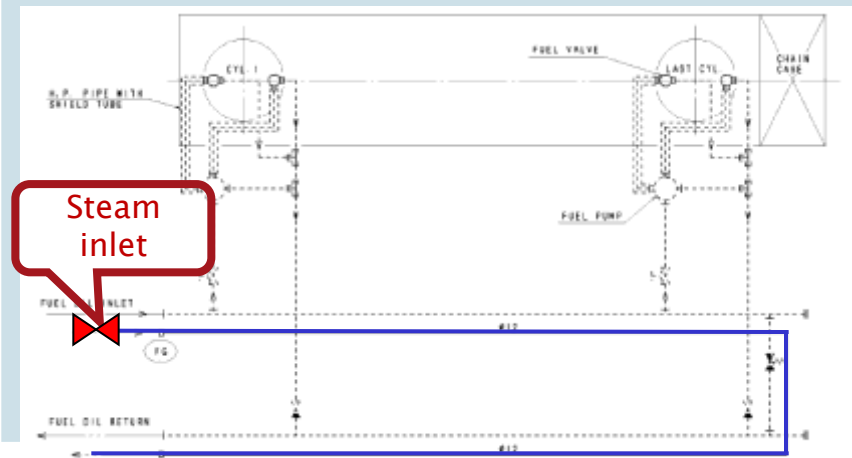
1. Fluctuation of fuel oil pressure
2. Much amount of fuel oil drain from lower pump cylinder

Cause

Engine inlet FO viscosity was less than 2 cSt. due to high temp.

Much fuel oil leak down to drain line.
About 10L/h fuel drain can be seen at shop test.

1. Renewed inlet valve for FO steam tracing pipe.
2. Closed valve completely for FO heater and changed into by-pass line for FO heater.

Countermeasure

Fuel oil line and steam tracing line are to be checked surely before using MGO.
