SERVICE NOTE

MITSUI ENGINEERING & SHIPBUILDING CO., LTD.
DIESEL TECHNICAL INVESTIGATION GROUP.

for MITSUI—MAN B&W engines, Low Load Operation (Special attention and modification based on recent service experience)		No. 179	
		APPROVED	N. Osako
		CHECKED	
		PREPARED	M. Kotake
ENGINE TYPE	All engines	DATE	27thAug. 2012

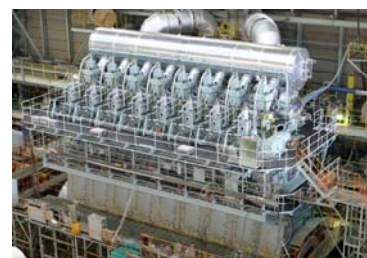
In connection with continuous low-load operation and, thereby, increased operation time of auxiliary blowers (A/B), an increasing number of troubles of the A/B has been reported. An increased running hours will require increased maintenance, but still a number of troubles have been reported.

Fig. 1: Aux. blower

It is recommended to open the valve equipped at the top of venting hole at least once a week regularly for drain from the venting pipe. This valve can open and close during engine operation. Change the shaft sealing if an excessive air amount is experienced from the drain.

This is also described in the service note No.169, it is a general recommendation to carry a complete spare blower on board the vessel if low-load operation is employed for longer periods
